PHOTODOCUMENTATION LOG SHEET
Turkey Brook Site • Oakville, Connecticut

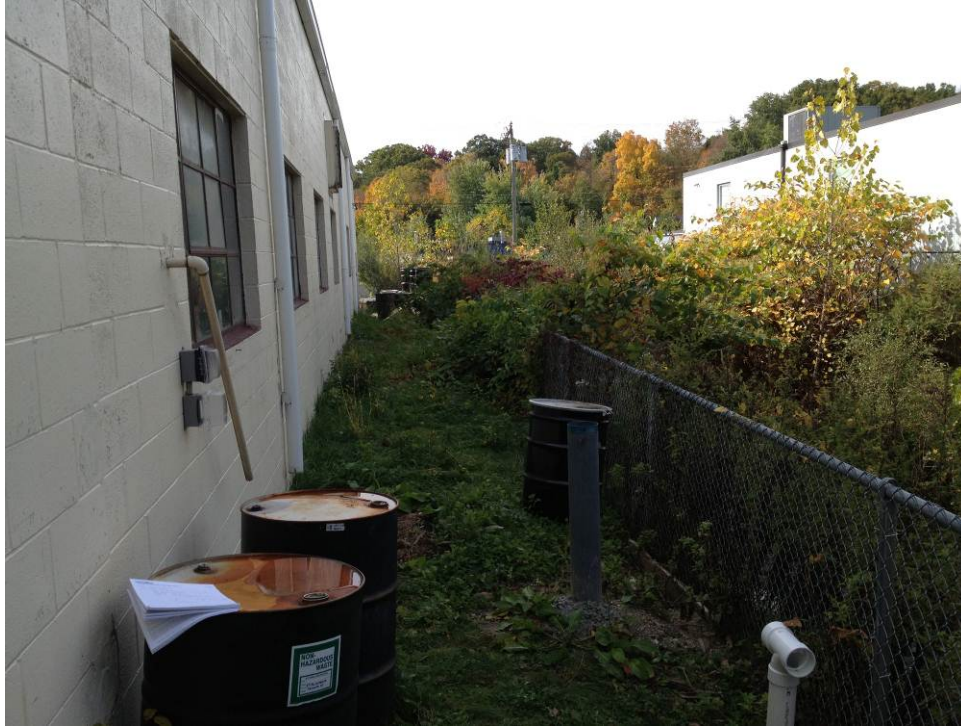
SCENE: View of west side of Quality Automatics, Inc. building, vent pipe, and staged 55-gallon drums. Photograph taken facing southwest.

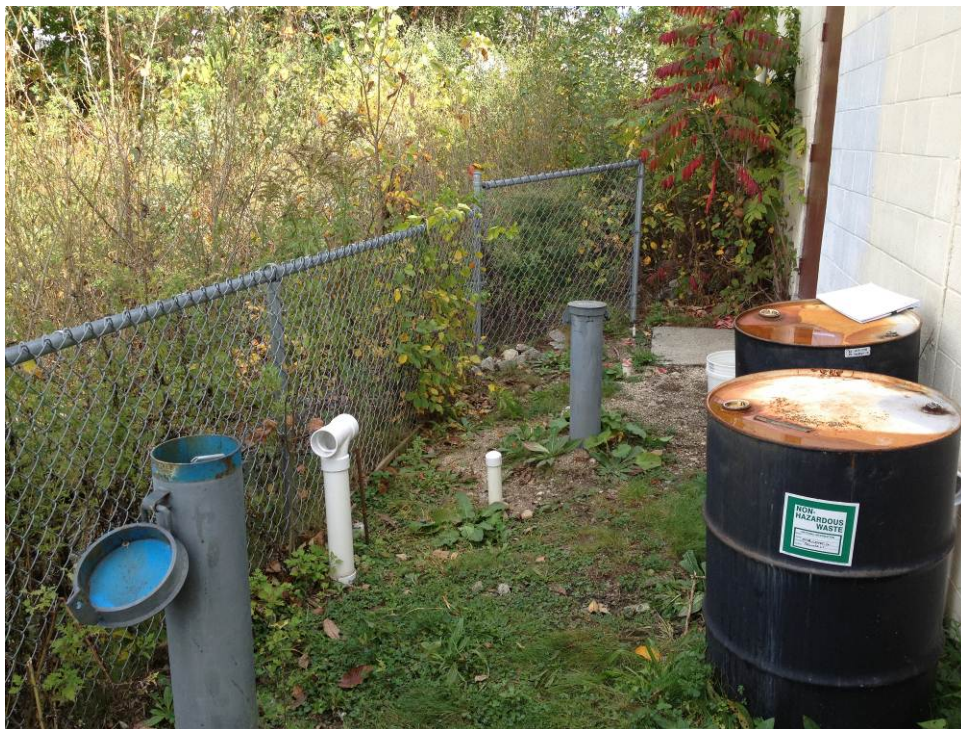
SCENE: View of monitoring wells, T-shaped pipe, and 55-gallon drums located on west side of Quality Automatics, Inc. building. Photograph taken facing northeast.

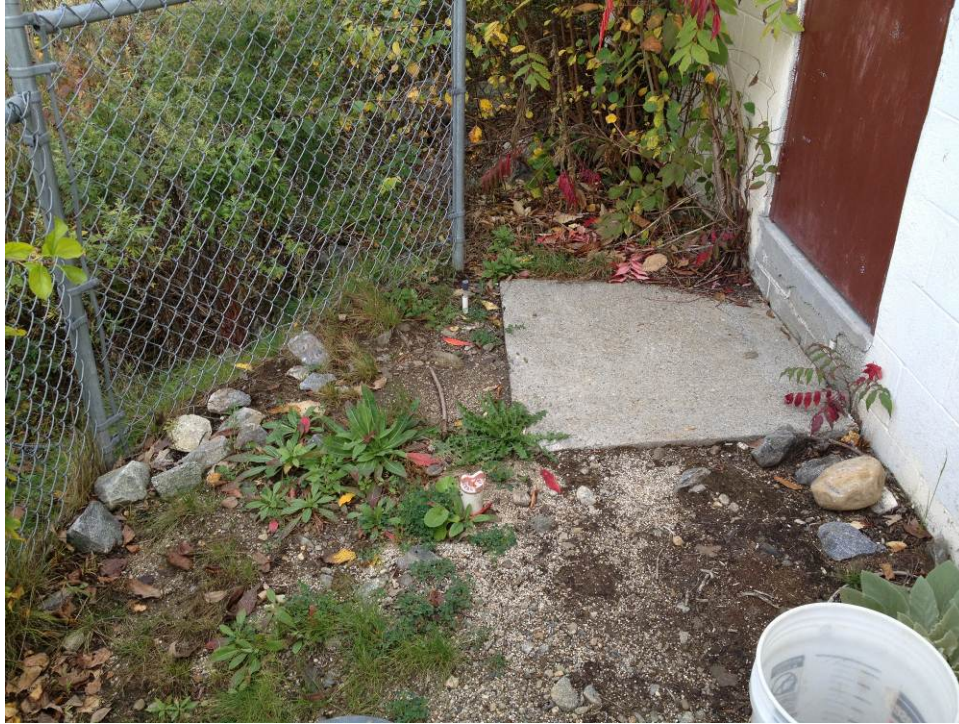
SCENE: View of piezometer and monitoring well located on west side of Quality Automatics, Inc. building. Photograph taken facing northeast.

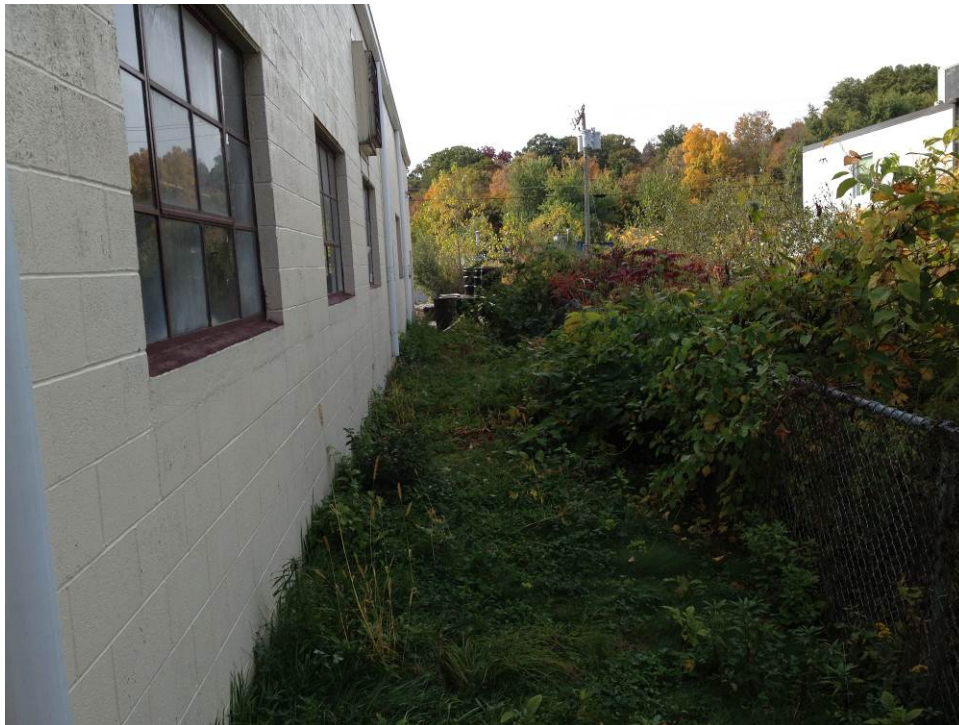
SCENE: View of grassy area along west side of Quality Automatics, Inc. building. Photograph taken facing southwest.

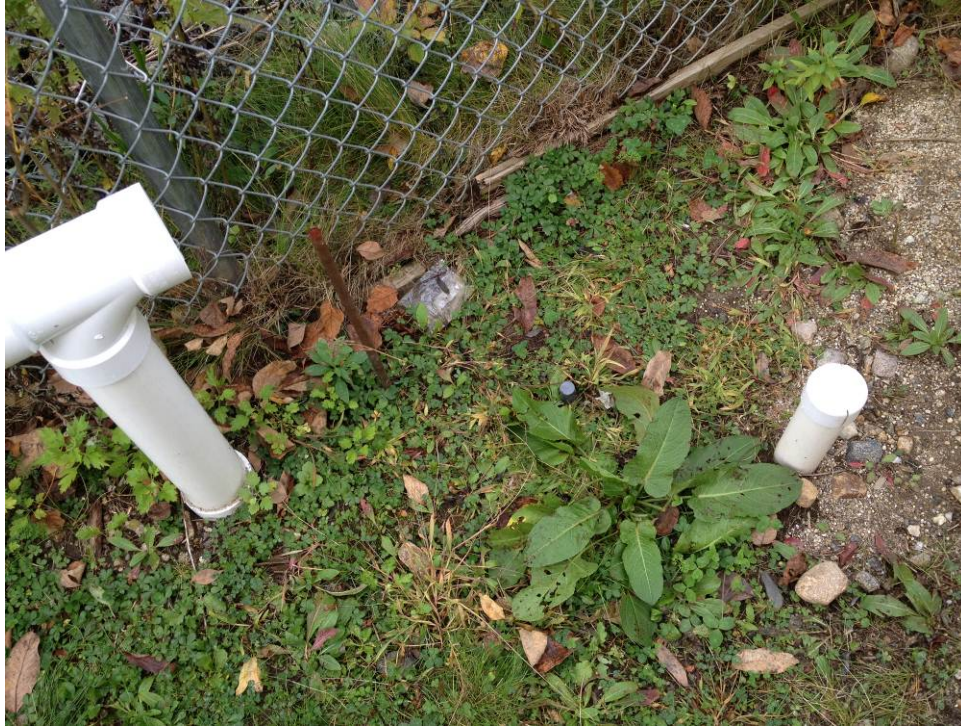
SCENE: View of T-shaped pipe and 2-inch monitoring well located on the ground surface along the northwestern side of the Quality Automatics, Inc. building. Photograph taken facing northwest.

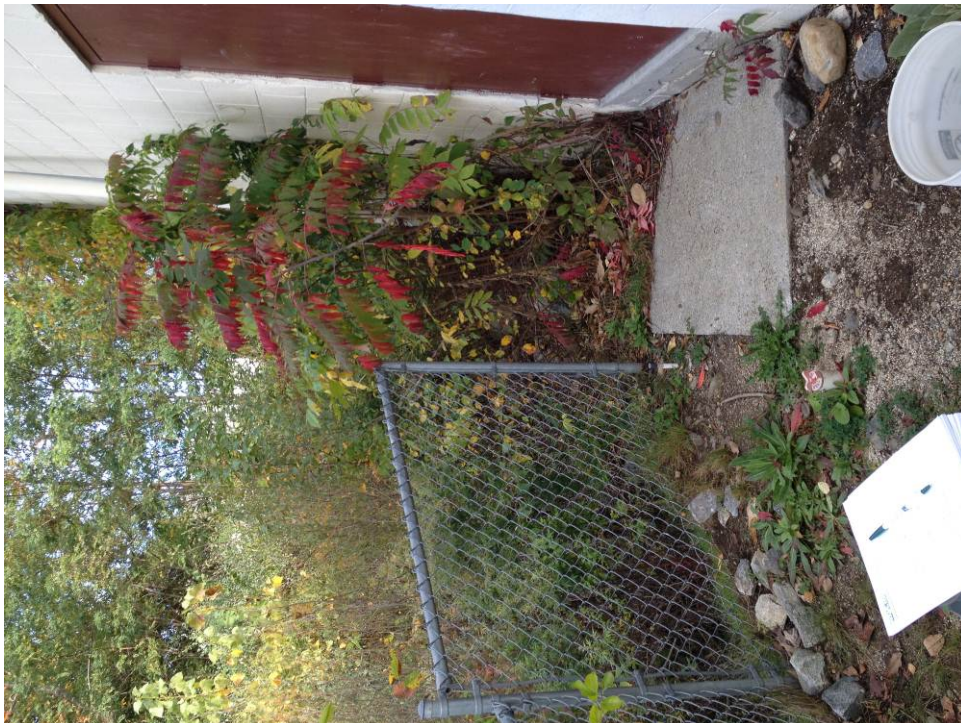
SCENE: View of 2-inch and 0.5-inch monitoring wells located left of concrete pad and directly in front of back door to the Quality Automatics, Inc. building. Photograph taken facing northeast.

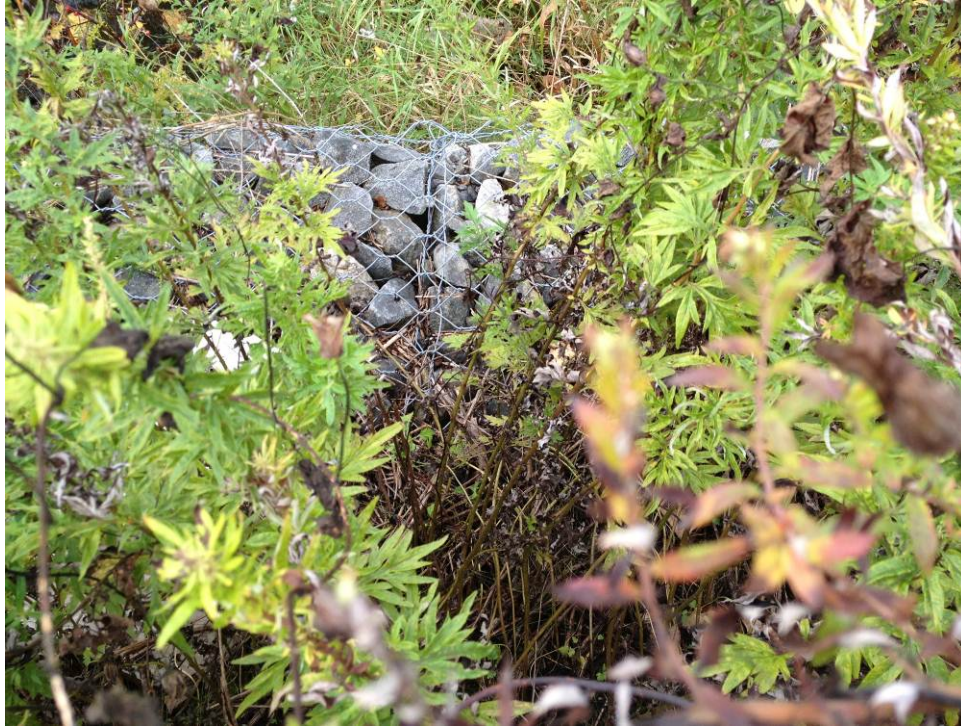
SCENE: View of gabions along east bank of Turkey Brook adjacent to Quality Automatics, Inc. building. Photograph taken facing northwest.

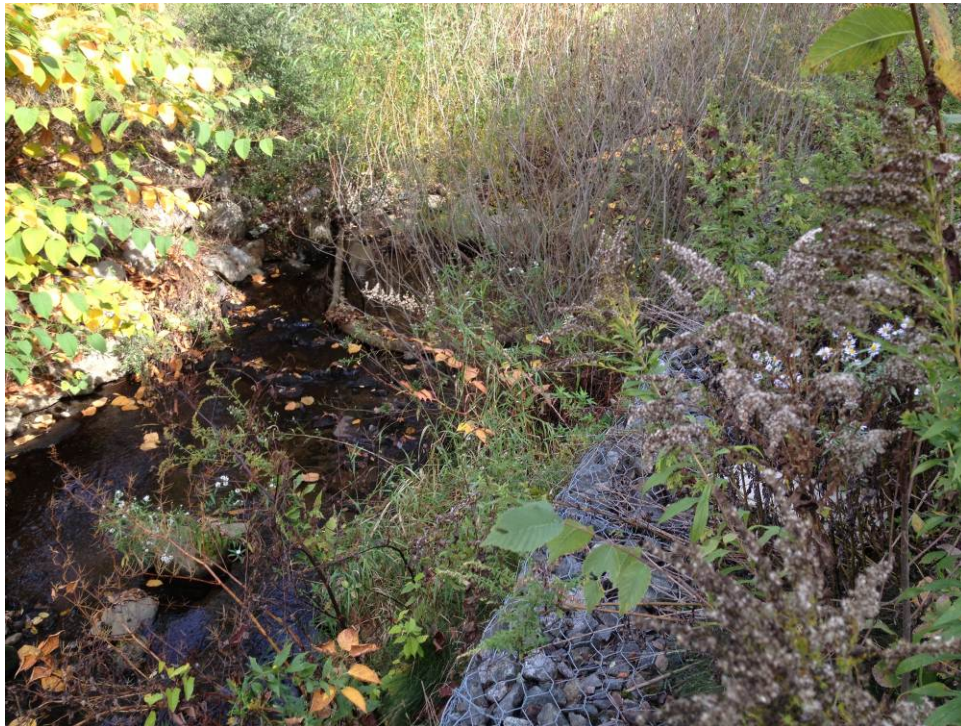
SCENE: View of oil absorbent boom located in Turkey Brook and upstream of monitoring wells on the Quality Automatics, Inc. property. Photograph taken facing northeast.

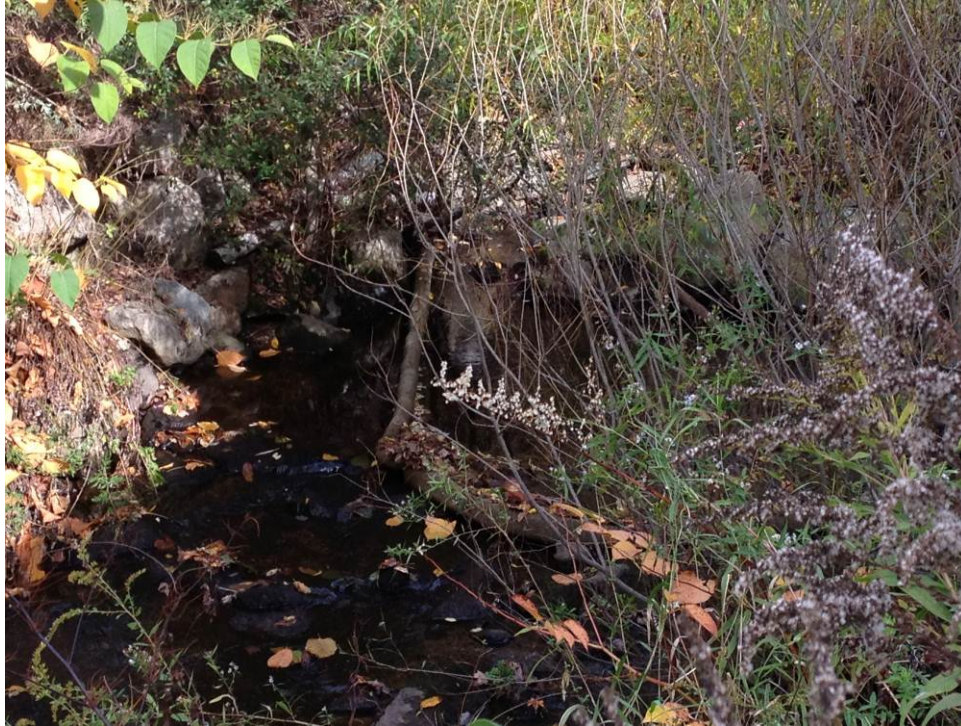
SCENE: View of oil absorbent boom located in Turkey Brook and upstream of monitoring wells on the Quality Automatics, Inc. property. Photograph taken facing northeast.

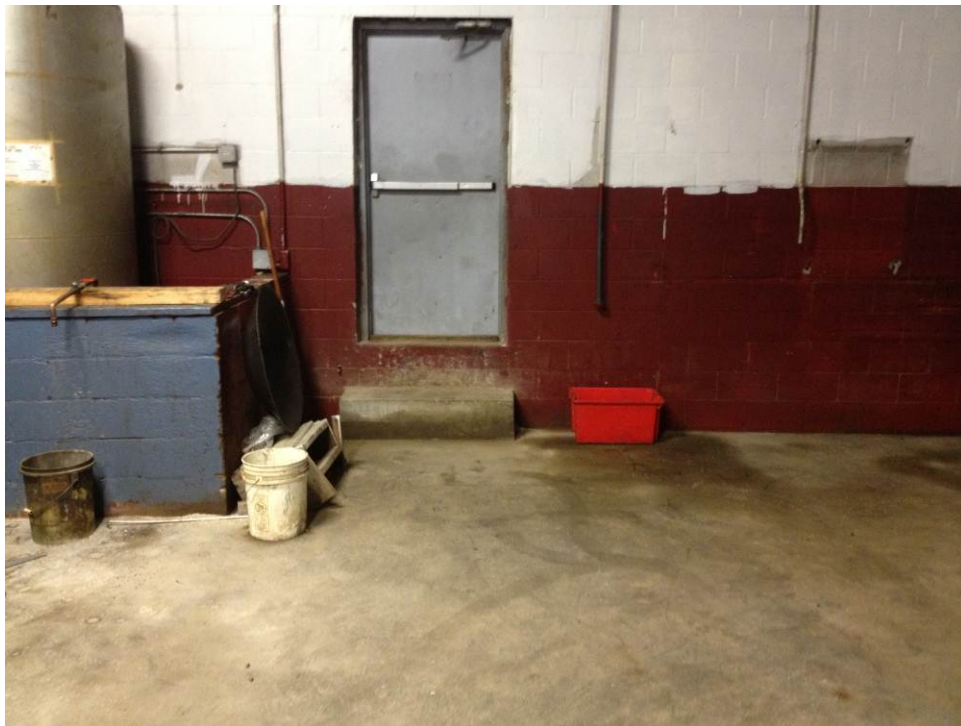
SCENE: View of back door of Quality Automatics, Inc. building leading outside to location of monitoring wells, and a solvent tank. Photograph taken facing northwest.

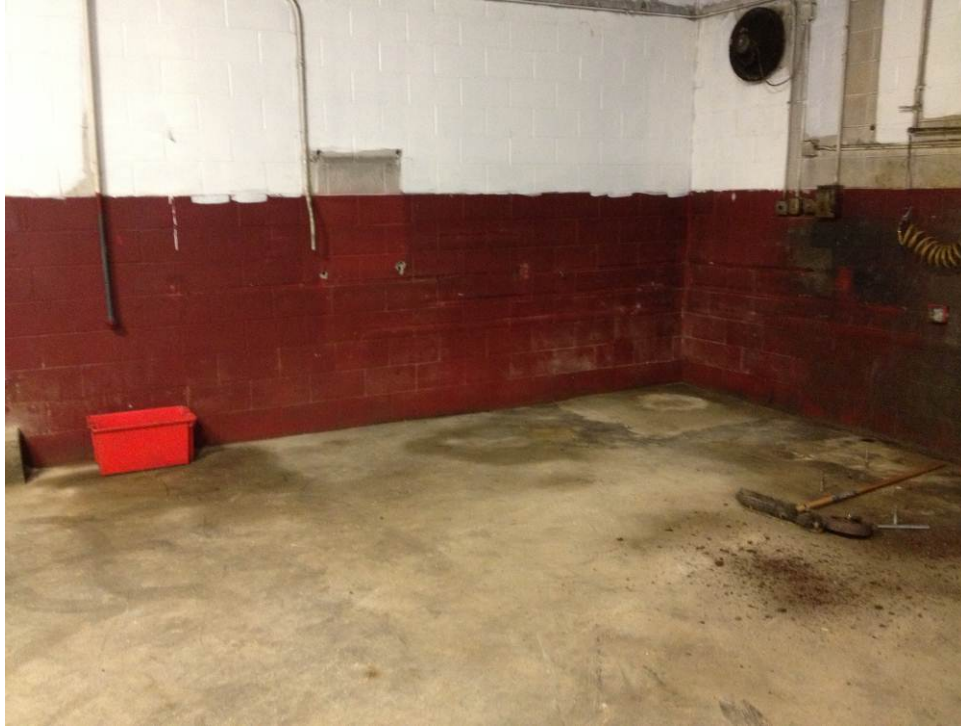
SCENE: View of northwest corner of Quality Automatics, Inc. building. Photograph taken facing northwest.

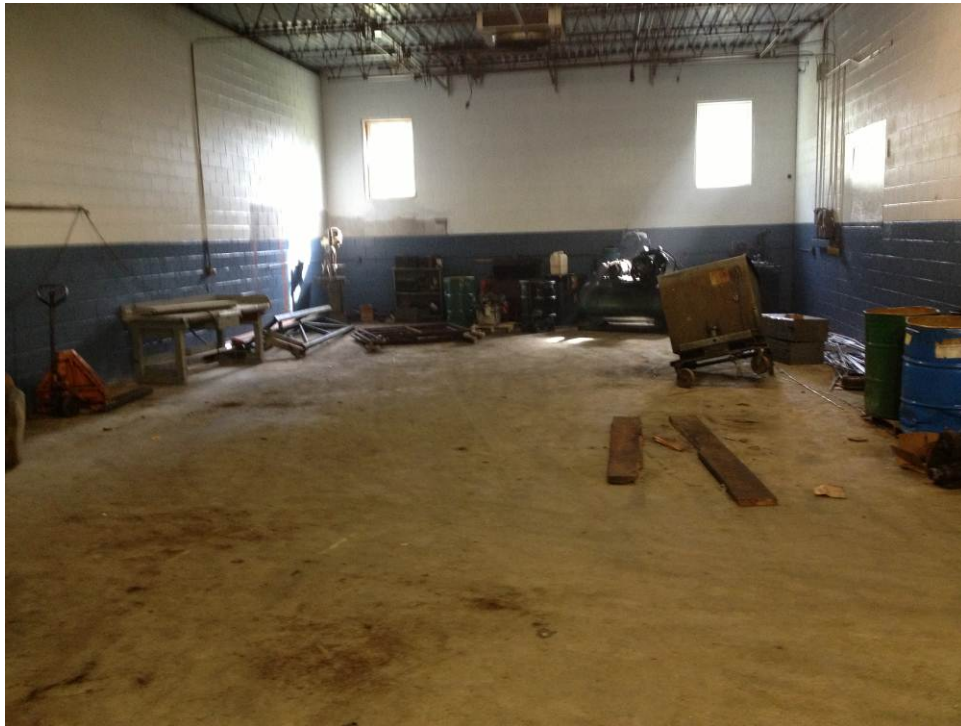
SCENE: View of back (northern) section of Quality Automatics, Inc. building. Photograph taken facing southeast.

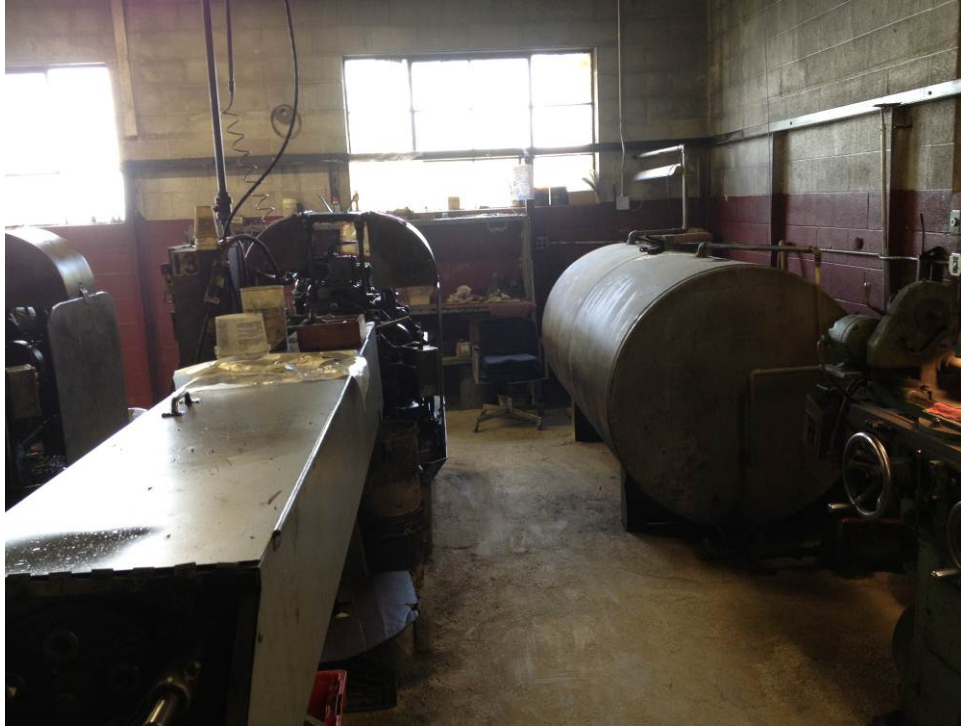
SCENE: View of large aboveground storage tank located in northwest section of the machine shop in the Quality Automatics, Inc. building. Photograph taken facing northwest.

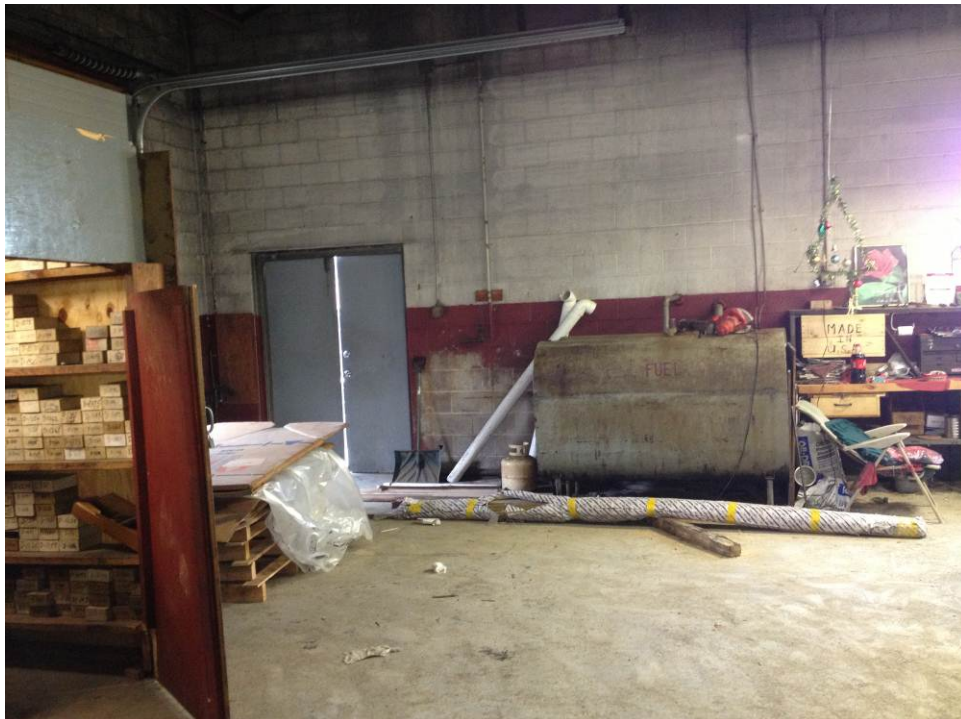
SCENE: View of 275-gallon aboveground storage tank located in southwest section of the machine shop in the Quality Automatics, Inc. building. Photograph taken facing southeast.

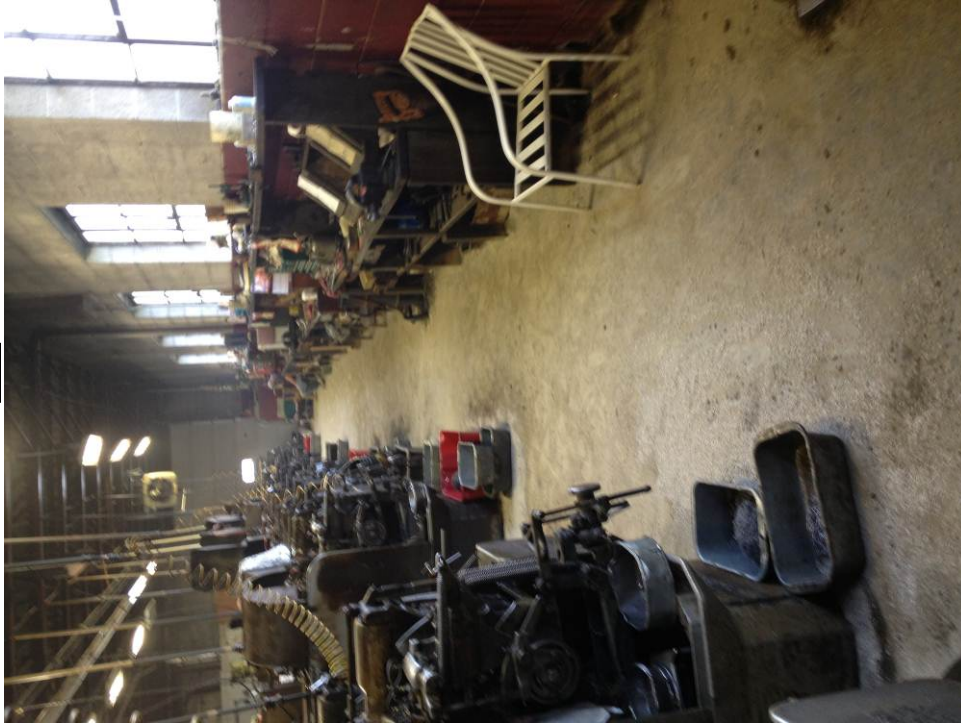
SCENE: View of western side of machine shop in the Quality Automatics, Inc. building. Photograph taken facing southwest.

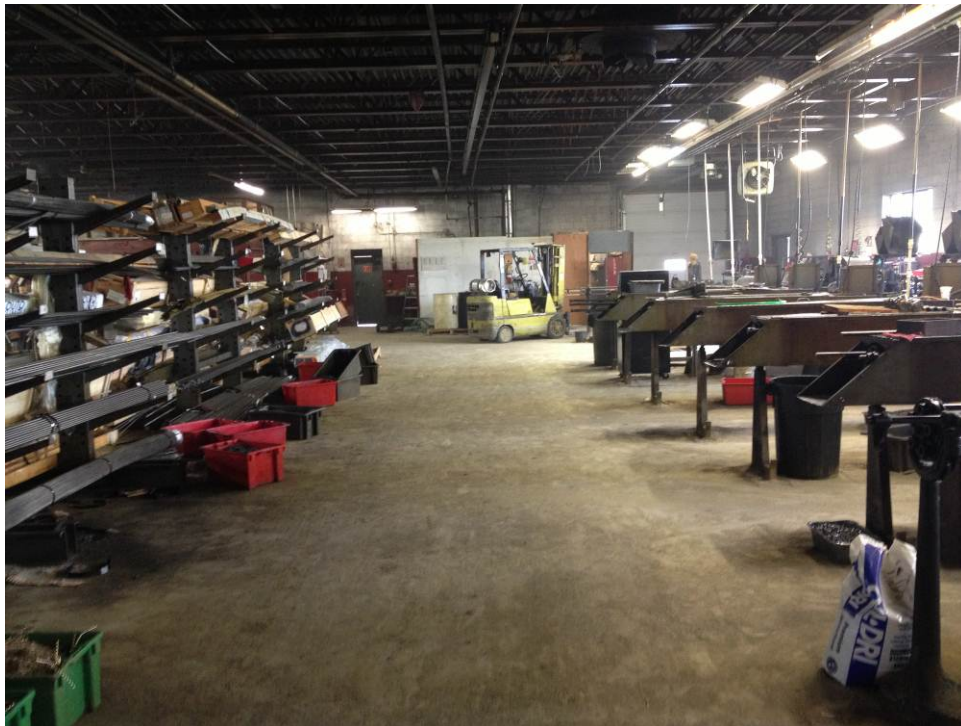
SCENE: View of right-center aisle of machine shop in the Quality Automatics, Inc. building. Photograph taken facing southwest.

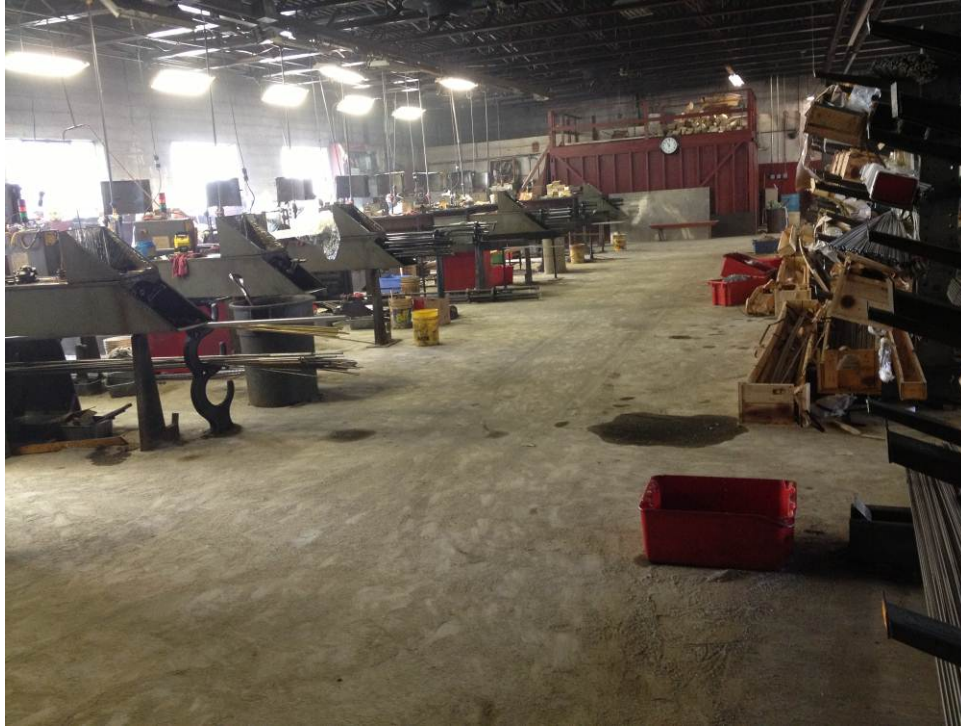
SCENE: View of left-center aisle of machine shop in the Quality Automatics, Inc. building. Photograph taken facing southwest.

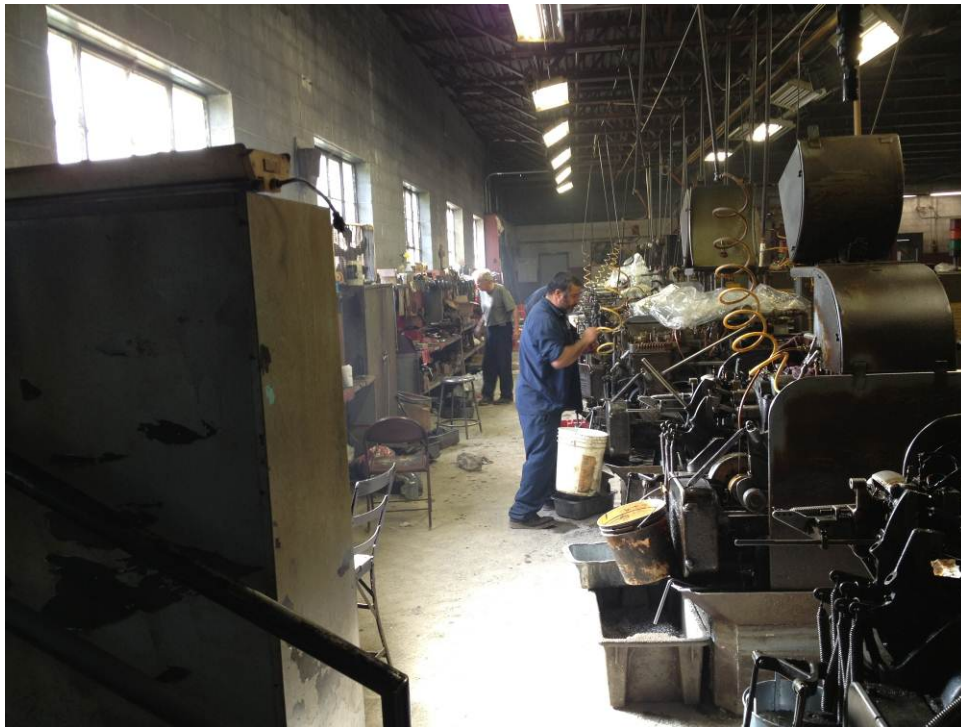
SCENE: View of eastern aisle of machine shop in the Quality Automatics, Inc. building. Photograph taken facing southwest.

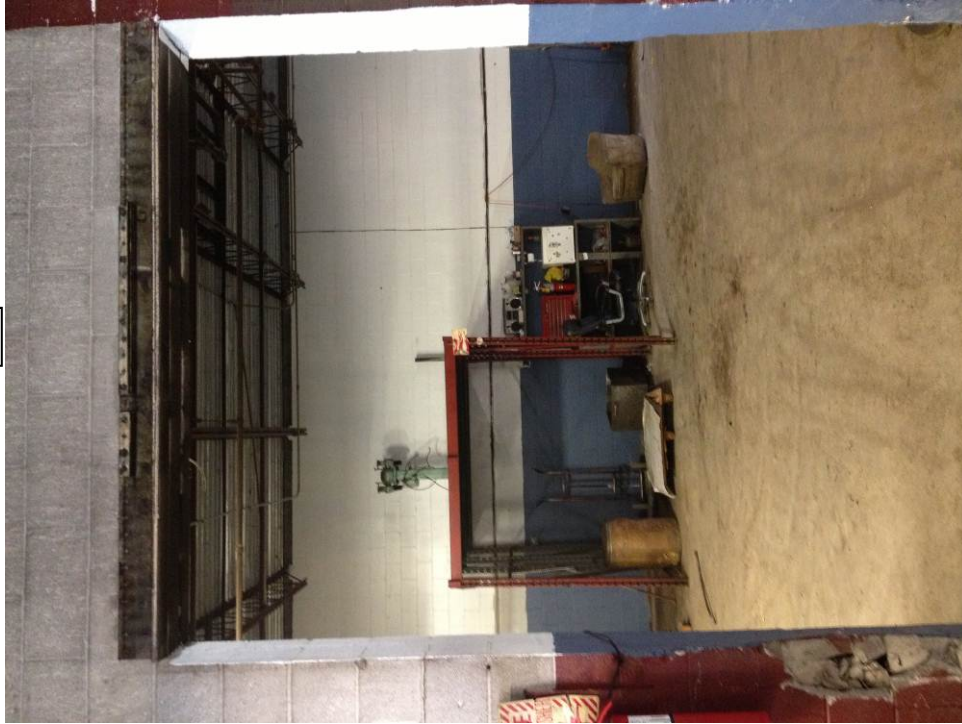
SCENE: View through doorway leading into northern room of Quality Automatics, Inc. building. Photograph taken facing northeast.

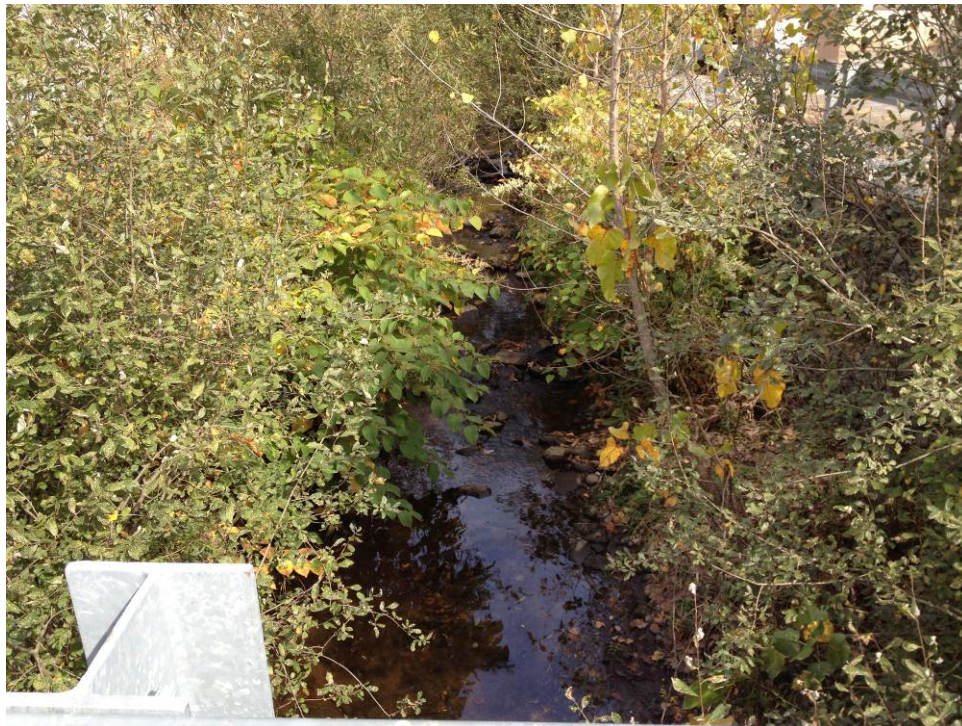
SCENE: Upstream view of Turkey Brook from McLellan Drive. Photograph taken facing northeast.

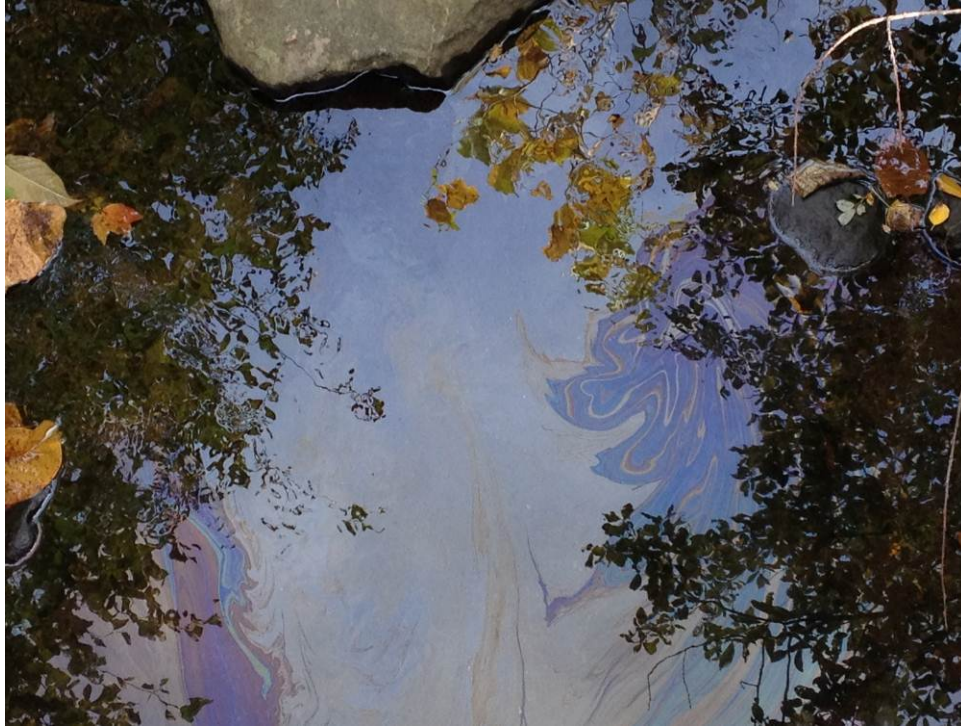
SCENE: View of sheen on Turkey Brook upstream of oil absorbent boom and north of McLellan Drive. Photograph taken facing northeast.

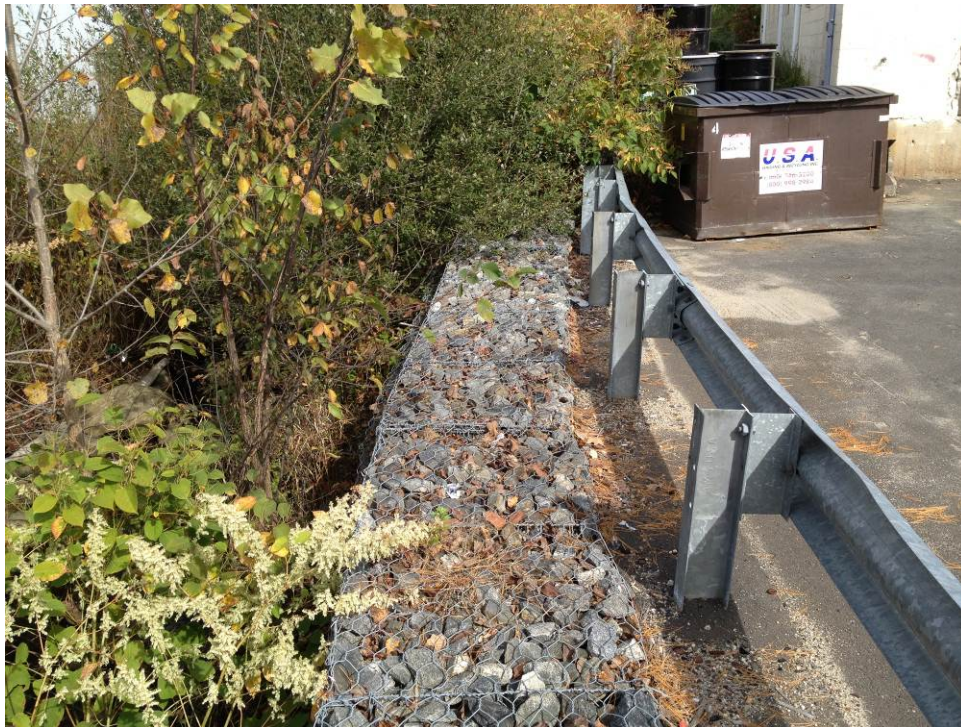
SCENE: View of gabion reinforcing eastern bank of Turkey Brook adjacent to the Quality Automatics, Inc. building. Photograph taken facing northeast.

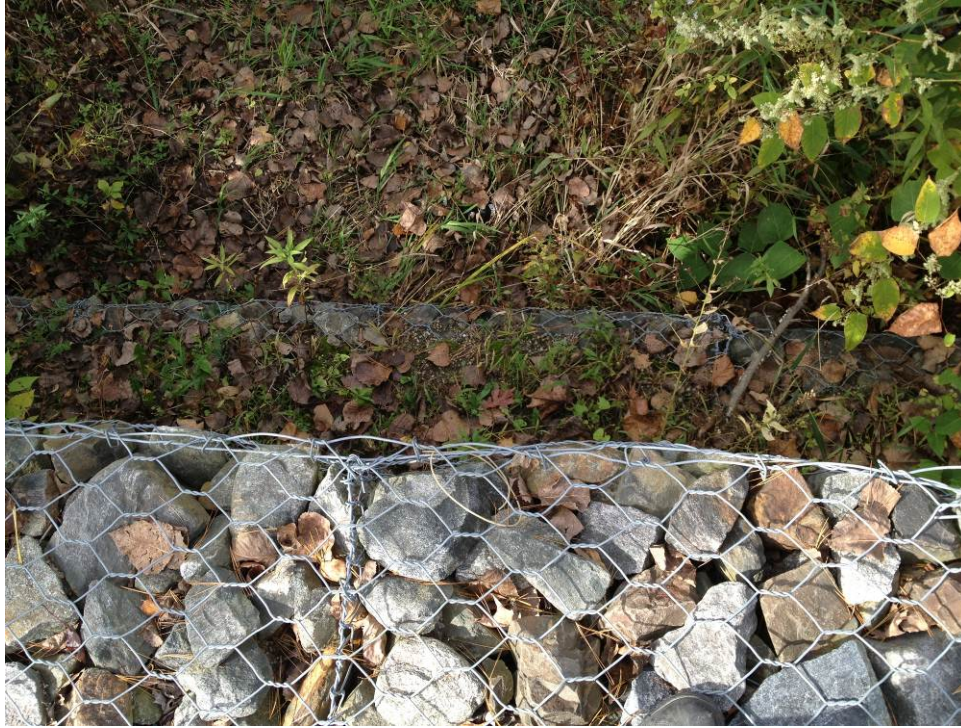
SCENE: View of stacked gabions along eastern bank of Turkey Brook adjacent to the Quality Automatics, Inc. building. Photograph taken facing northwest.

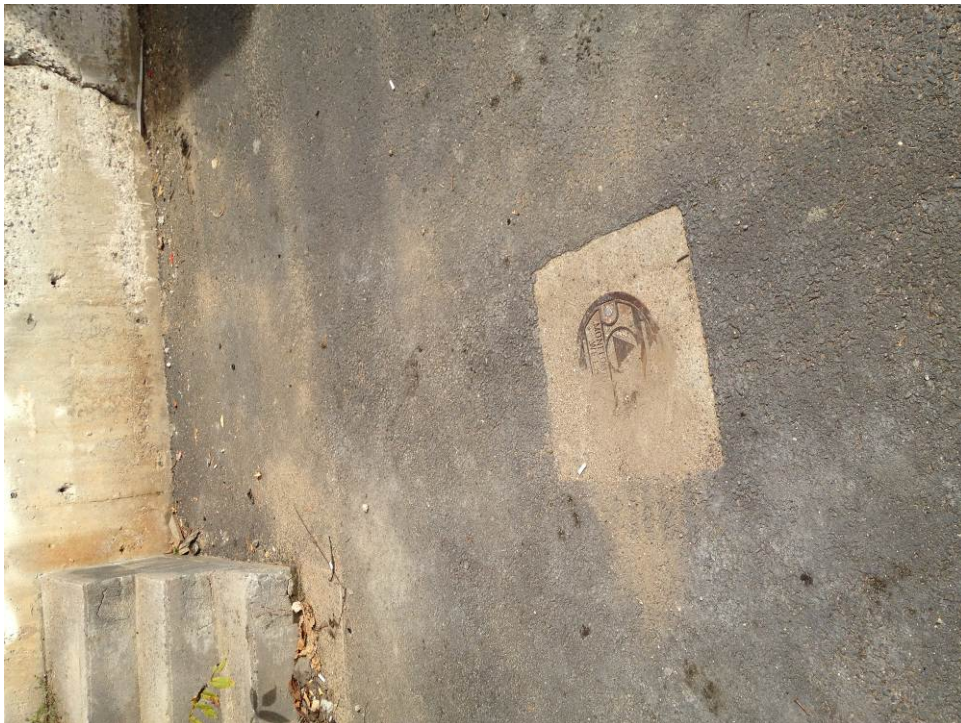
SCENE: View of monitoring (number unknown) located in front of bay door of Quality Automatics, Inc. building. Photograph taken facing northeast.

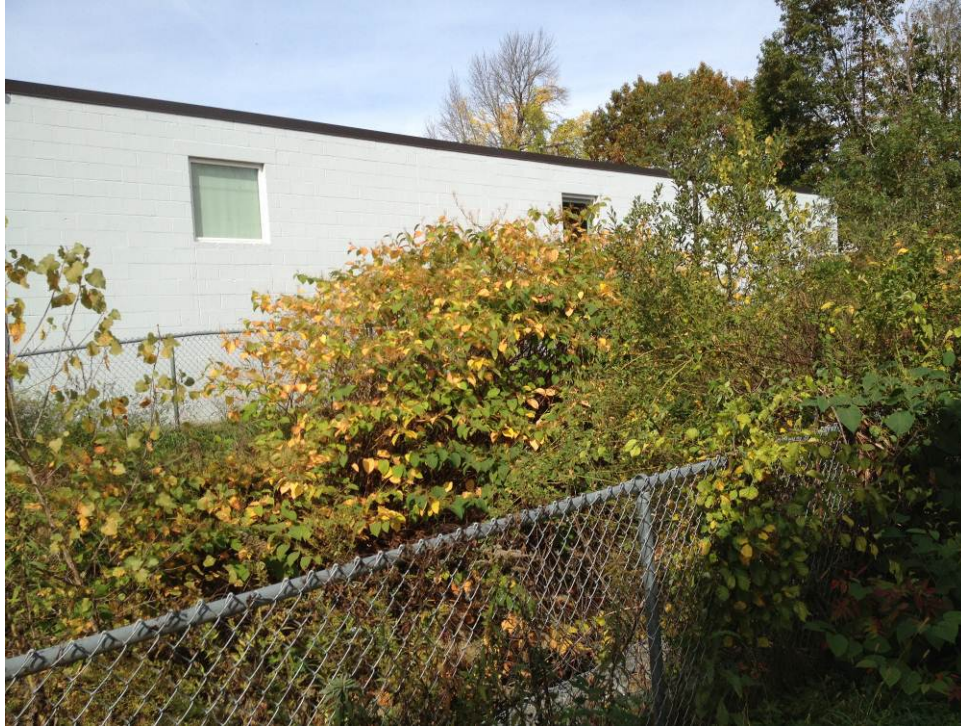
SCENE: View of Rintec Corporation Building located along west side of Turkey Brook and adjacent to Quality Automatics, Inc. Photograph taken facing northwest.

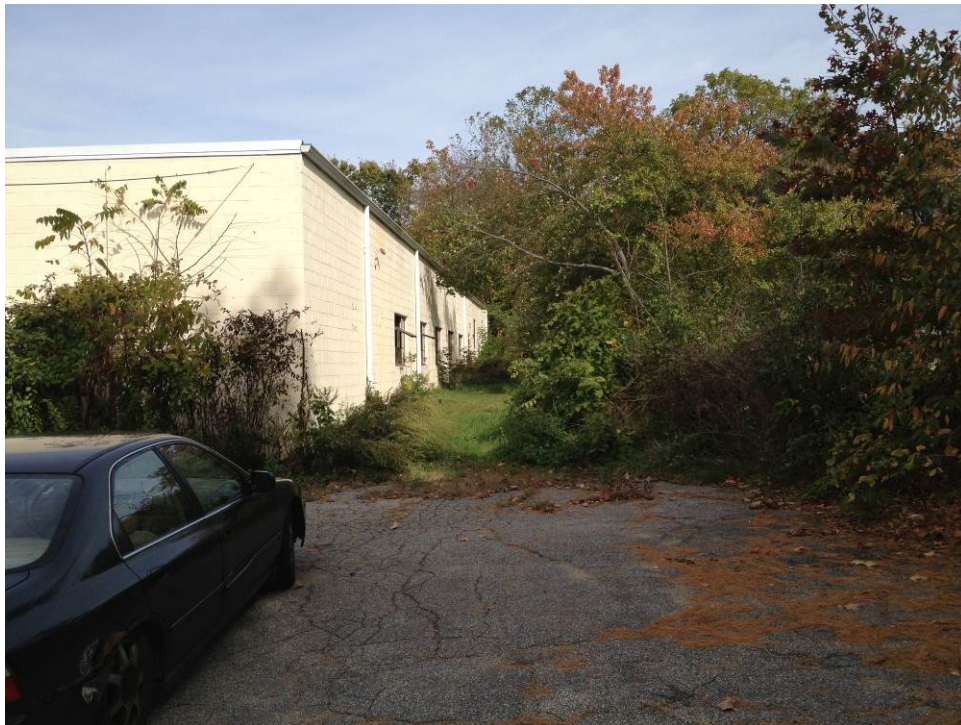
SCENE: View of eastern side of Quality Automatics, Inc. building. Photograph taken facing northeast.

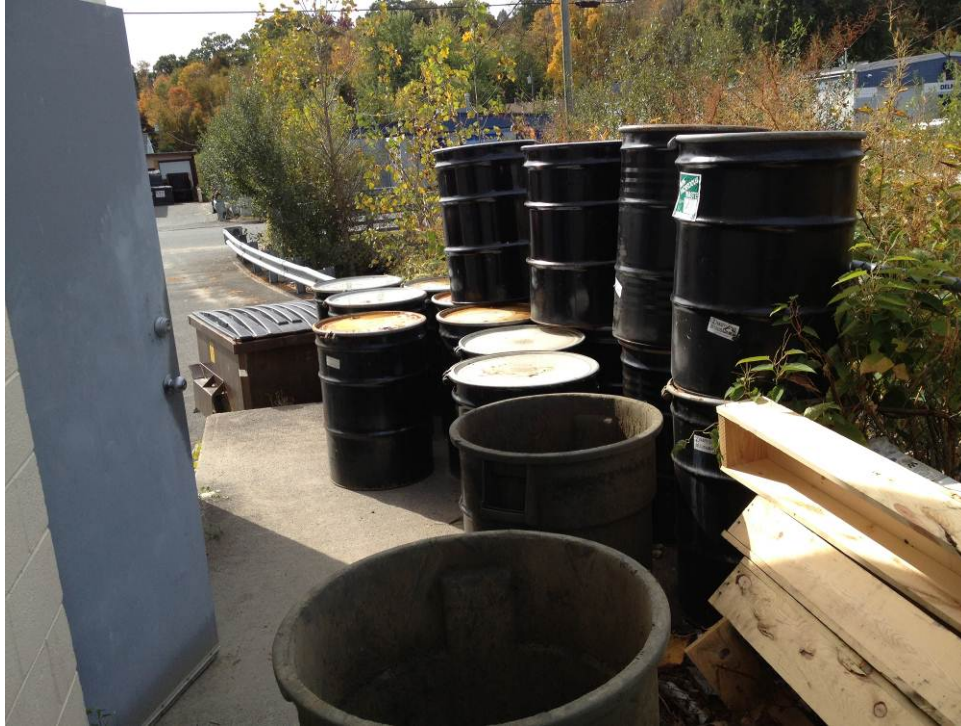
SCENE: View of 18 55-gallon drums containing used oil absorbent booms, located at southwestern corner of Quality Automatics, Inc. building. Photograph taken facing southwest.

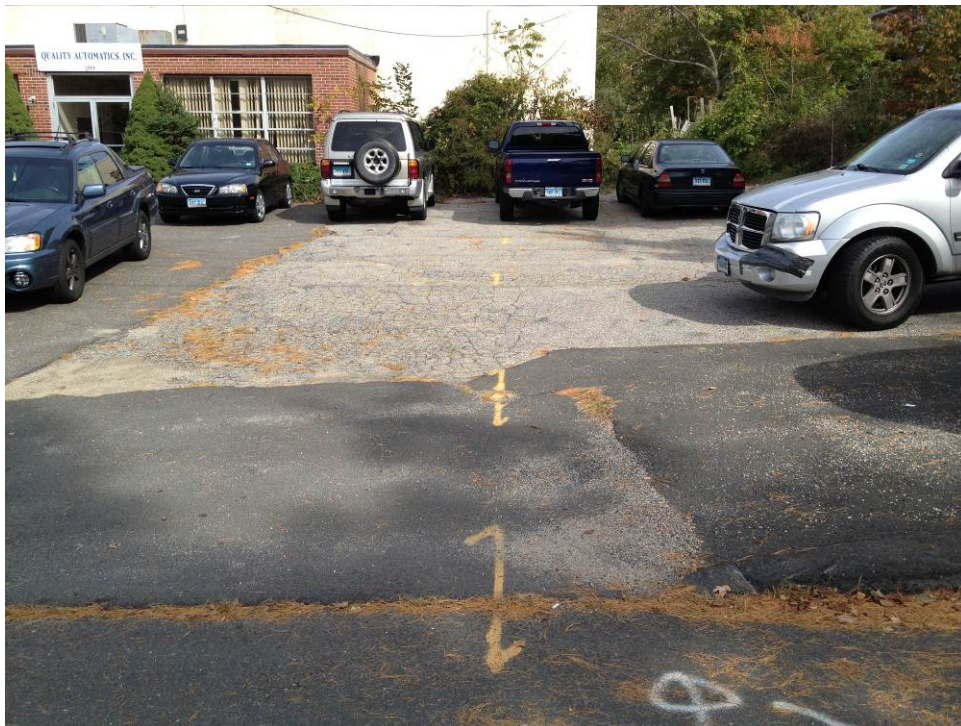
SCENE: View of gas line markings in parking lot of Quality Automatics, Inc. Photograph taken facing northeast.

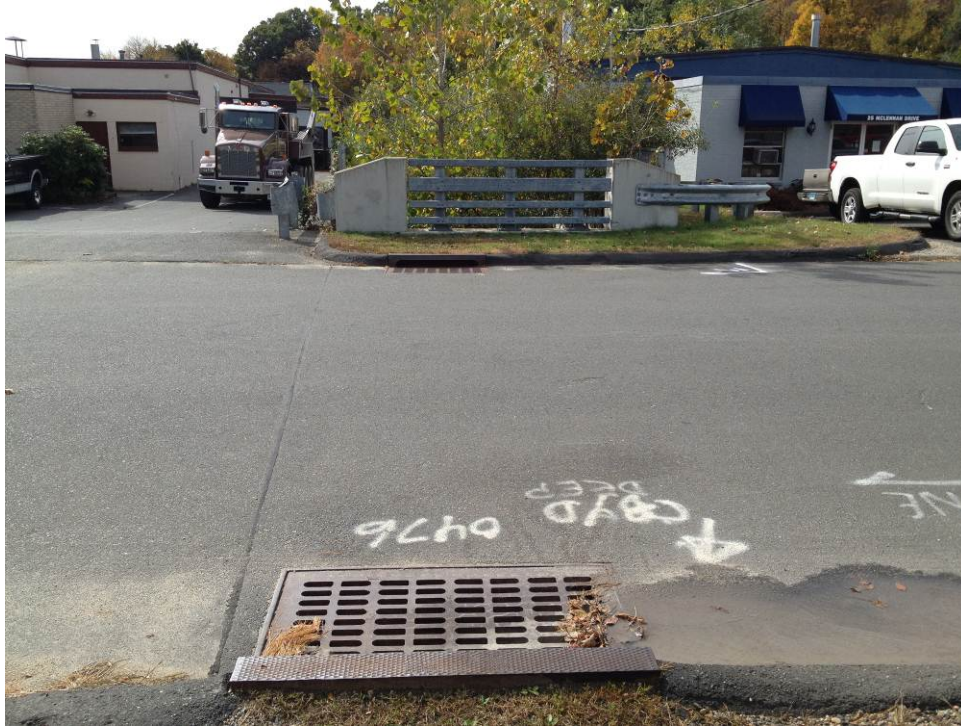
SCENE: View of two catchbasins located directly above Turkey Brook along McLellan Drive. Photograph taken facing northeast.

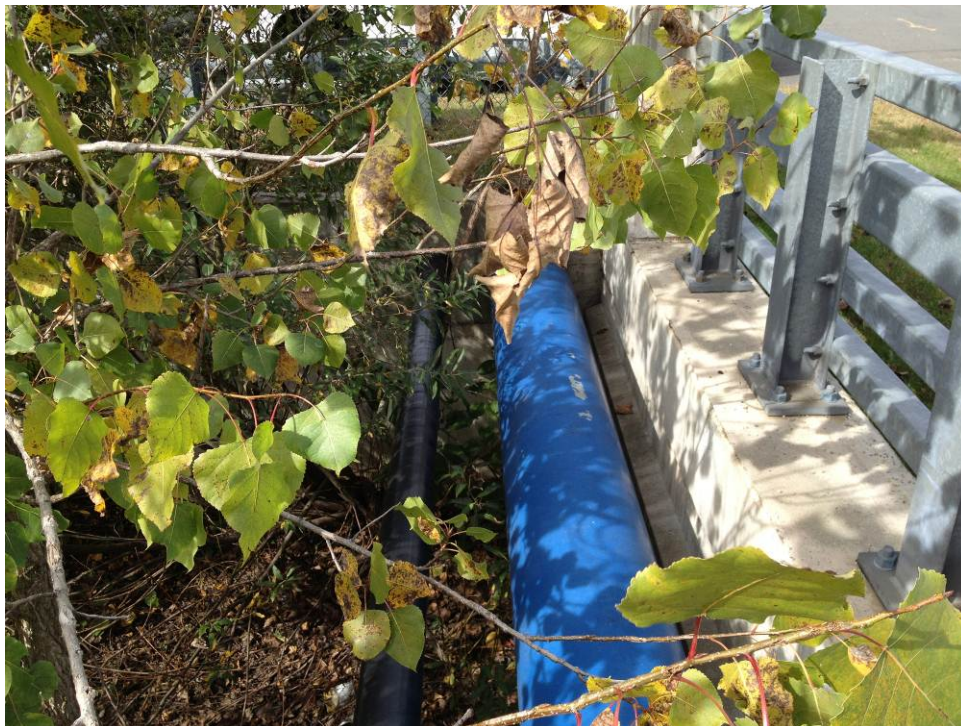
SCENE: View of blue and black pipes crossing Turkey Brook along southern side of McLellan Drive. Photograph taken facing northwest.

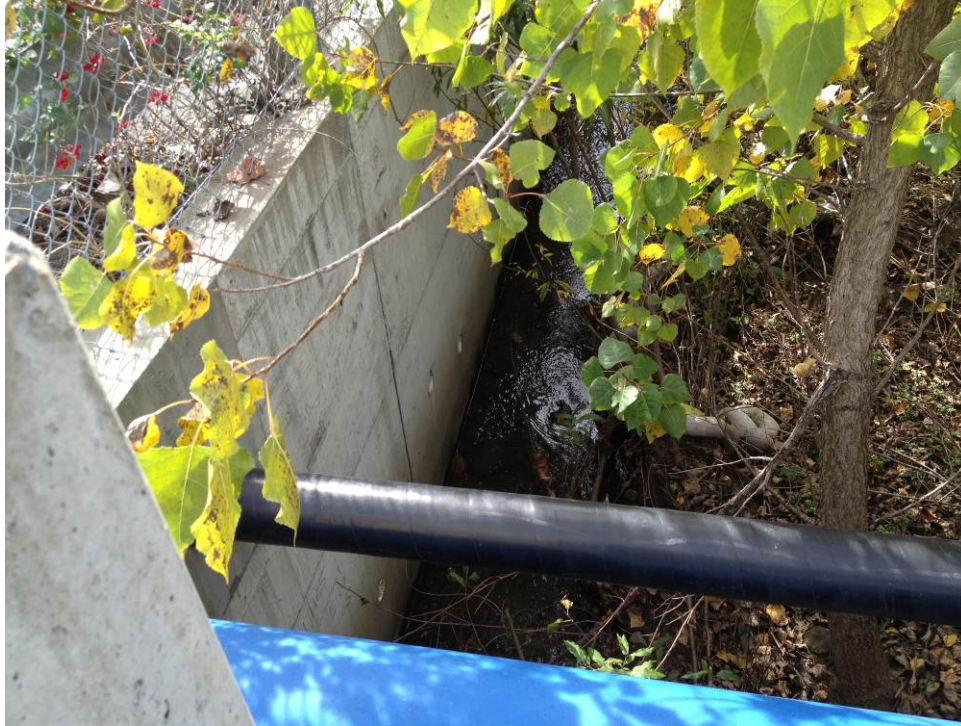
SCENE: View of blue and black pipes crossing Turkey Brook and surface water flowing along concrete wall adjacent to the Quality Automatics, Inc. facility located on south side of McLellan Drive. Photograph taken facing southwest.
